MOTORCYCLE DOCTOR LLC

Date:
03-28-2018

Hello to HiSun Engineer, this fix is to solve a Wet Shoe Clutch problem that many MTD / Cub Cadet dealers are complaining of chatter noise, excessive wear and internal Wet Shoe, Clutch Drum and 1-Way Bearing failure.

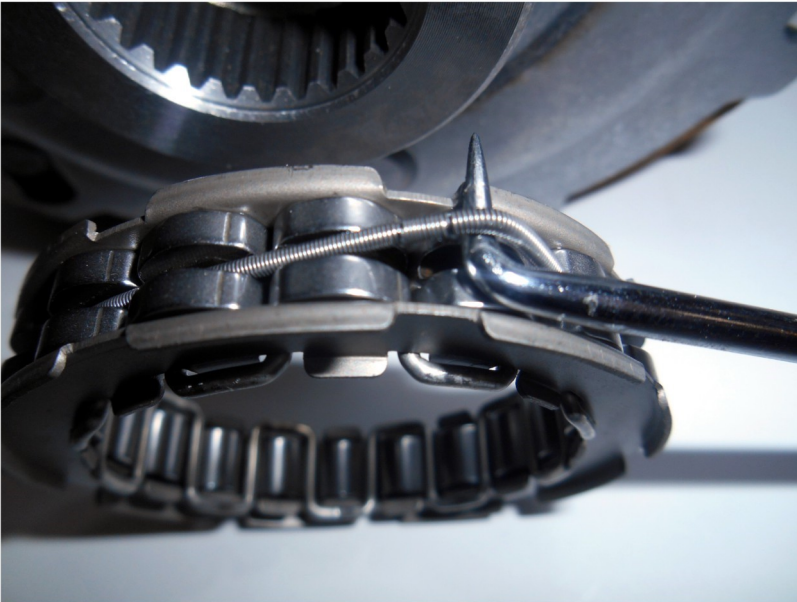
The lighter mass of the new 'Rare Earth Magnets' on the rotor allow a the whole crankshaft assy. to pulsate fast/slow and this makes the 1-way bearing to 'Lock and Unlock' because the Wet Shoe is Pulsating which makes the Sprag Prawl Bearings inside the 1-Way bearing to open too easy, causing the excess wear and failure.

Please replace this stock spring with a Higher Tension Spring before assembly.

Remove spring,
twist off connection.
