MOTORCYCLE DOCTOR LLC

Date:
03-28-2018

Hello to HiSun Engineer, this fix is to solve a Wet Shoe Clutch problem that many MTD / Cub Cadet dealers are complaining of chatter noise, excessive wear and internal Wet Shoe, Clutch Drum and 1-Way Bearing failure.

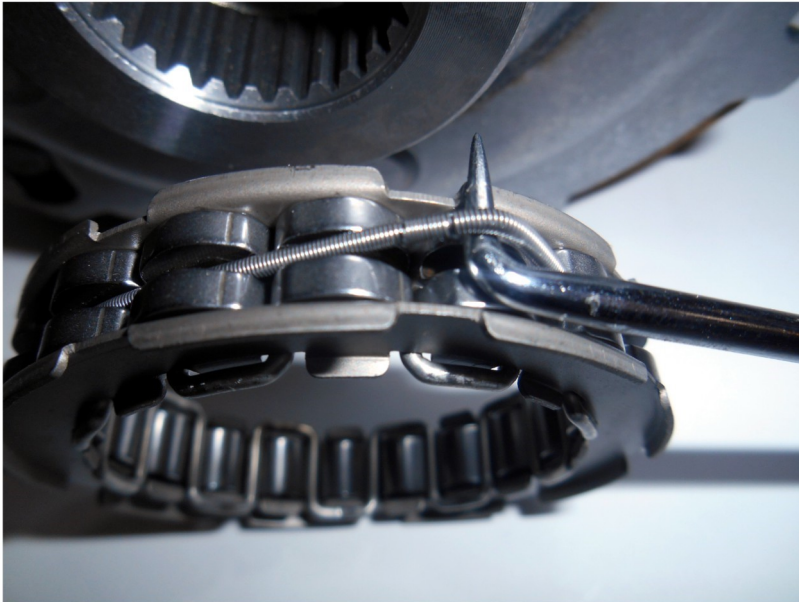
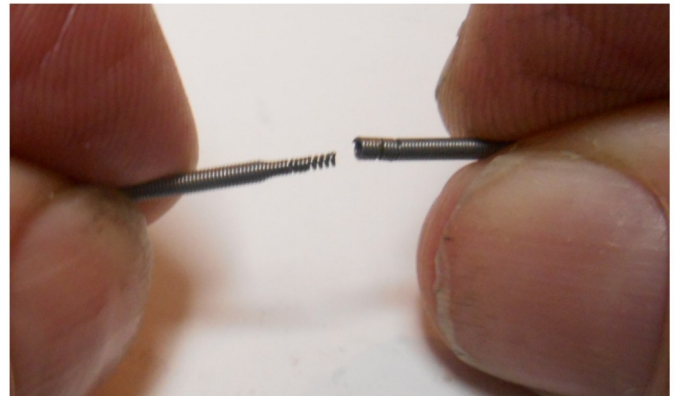
Please replace this stock spring with a Higher Tension Spring before assembly.

Remove spring,
twist off connection.
