Purpose

- It has been determined that some Strike 1000 Crew are experiencing unusually high temperatures in the exhaust piping in which heat is building within the muffler tube. Exhaust piping and internal muffler tube flame screen net have been upgraded to handle higher temperatures of heat. Version 2 components include double layered piping which reduces surface temperatures.

- Strike 1000 Crew

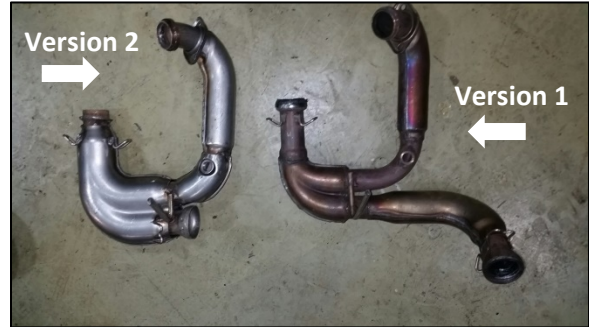
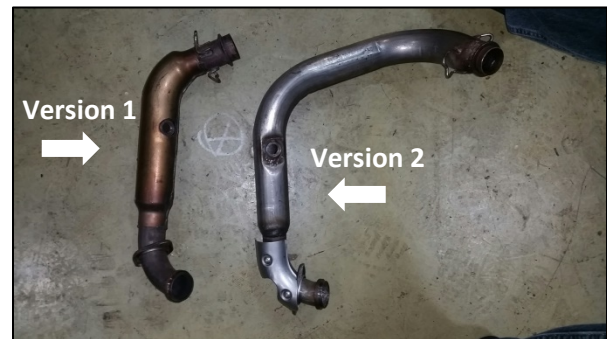
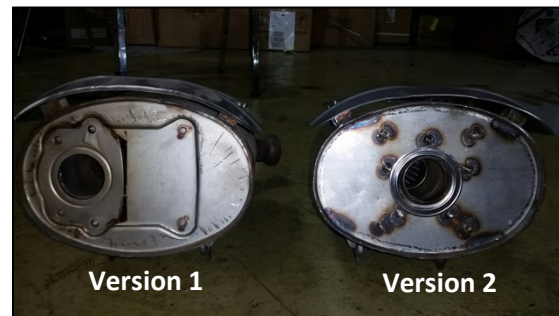
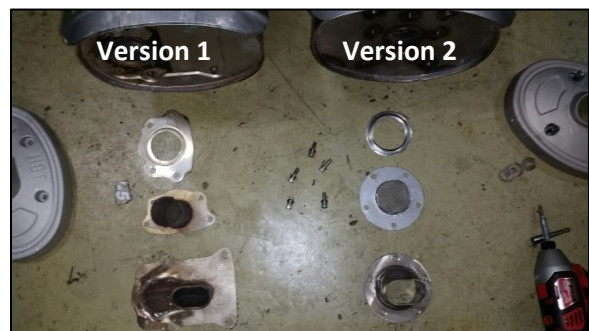
Part Items

- Exhaust Pipe I
- Exhaust Pipe II
- Muffler Tube Assembly
