## **Technical Service Bulletin**

TSB-160317-1

2015 HISUN UTV units affected SECTOR/STRIKE 250, SECTOR/STRIKE 1000, SECTOR/VECTOR 500-750 models.

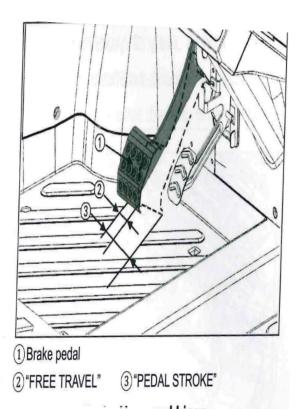
It has been determined that the some HISUN units are having brake issues, ie. Front/rear brakes locking up, brake lines blowing out at crimps and caliper seals, etc.

- 1. Remove cotter pin and connecting pin from brake pedal.
- 2. Remove connecting pin assy.
- 3. Loosen the jam nut and adjust accordingly.
- 4. Reinstall and check for proper free play (1/4"-1/2") #2 image below
