HiSun UTV 500 / 700 and possible others need to have this electrical plug repaired or at least inspected and Di-Electrical grease applied

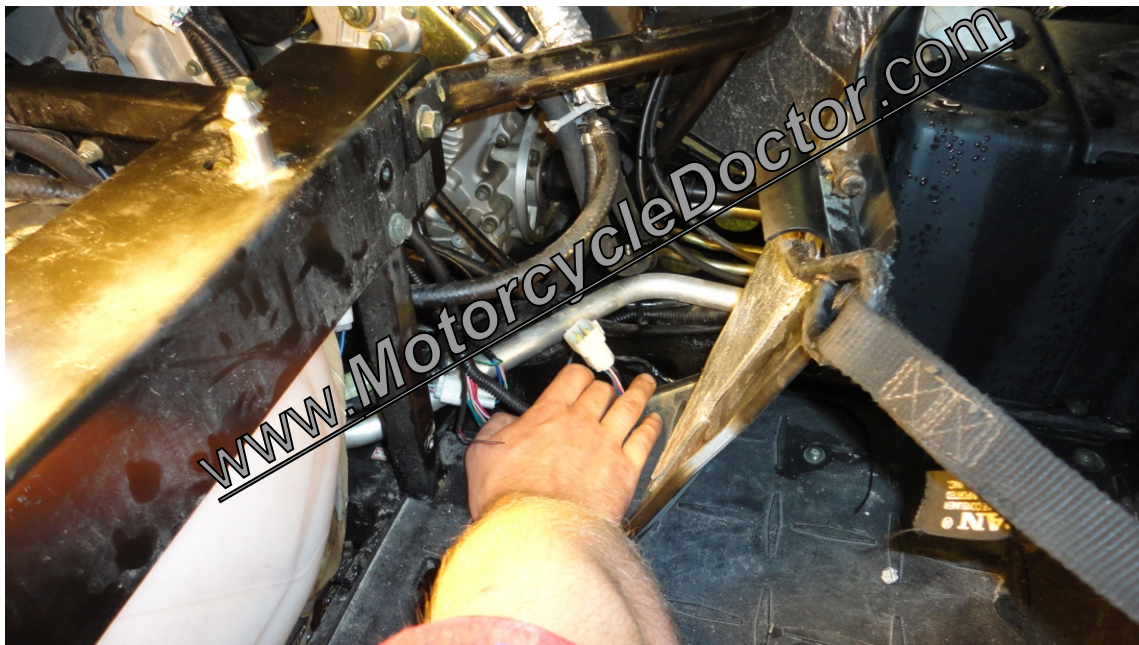
Here is the location, between the front of the tank and front output drive shaft, close or on the skid pan.
